**ADDENDUM TO THE EXPANDED SITE INVESTIGATION OF THE LAKE
CALUMET CLUSTER SITE**

**LAKE CALUMET CLUSTER SITE
ILD 000 716 852
CHICAGO, ILLINOIS**

**PREPARED BY:
ILLINOIS ENVIRONMENTAL PROTECTION AGENCY
BUREAU OF LAND
OFFICE OF SITE EVALUATION**

February 8, 2005

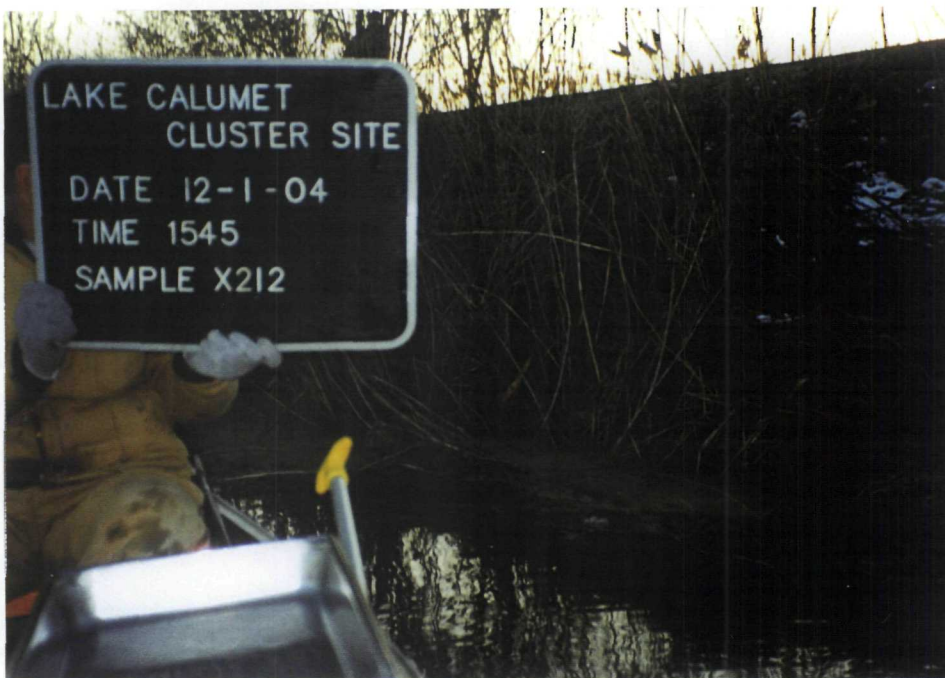
COMMENTS: Photo taken of X212. This location was located at the area designated to be the crossing of 119th Street and the RR tracks. Power lines run over this location. X212 consisted of a smelly very gravelly fill with not much sediment, this was black in color. Sample was collected from a depth of 1 to 2 feet. Water level in this area was approximately 2.5 ft deep.

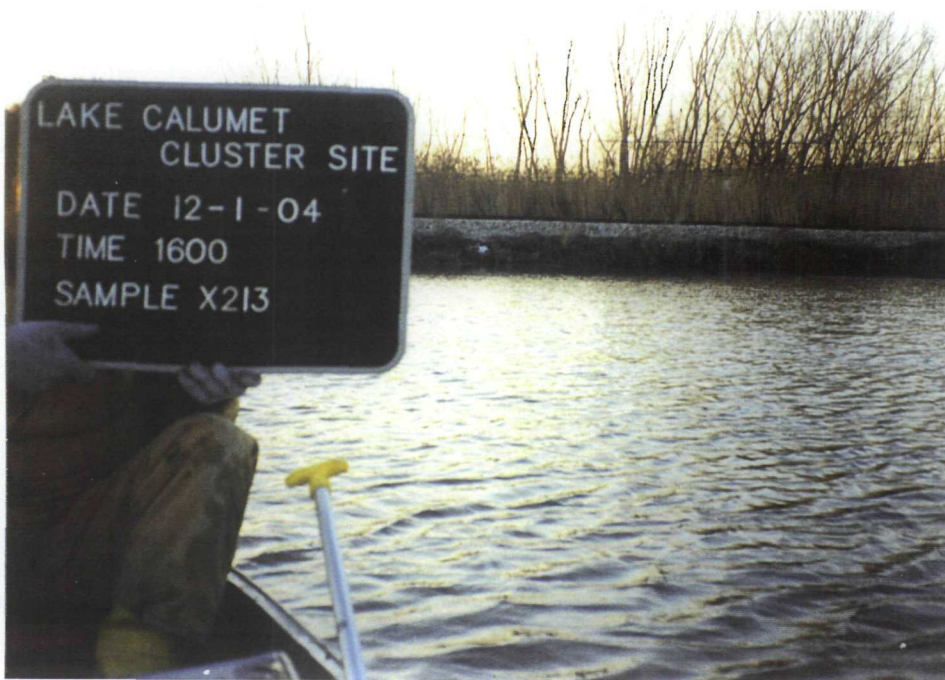
COMMENTS: Photo taken of sample X213. This sample was located north and east of the power lines crossing the RR tracks. This sample consisted of black silts that were of a spongy consistency. This sample was collected from a depth of 0-12 inches. This location was found to be covered by 2 ft of water.

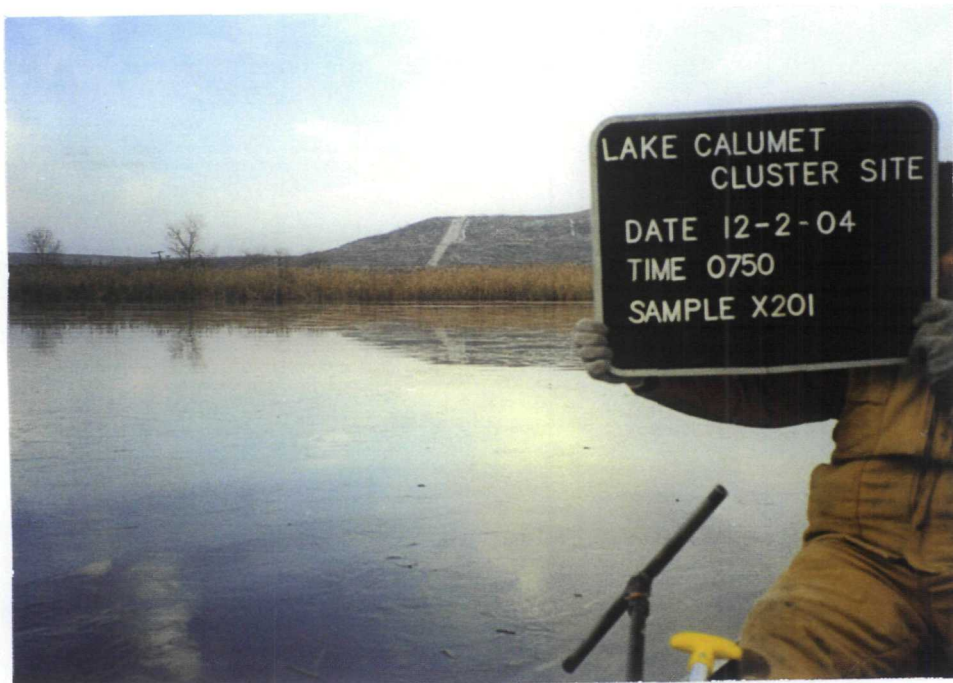
COMMENTS: Photo taken of Sample X201. Sample was collected from the northeastern portion of the marsh. This location was selected for the possibility of a background (location was upstream of the culvert). Sample consisted of a silty black silt and brown peat material. Sample was collected 2-12 inches from 3 ft of water.

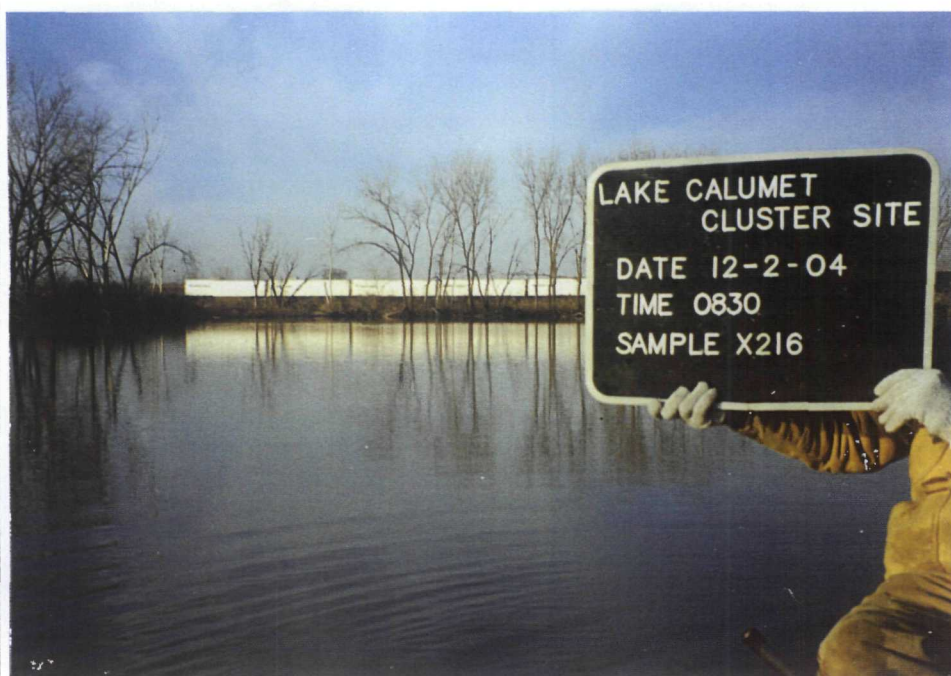
COMMENTS: Photo taken of sample X216. This sample was collected from an area almost blocked off from the main channel of marsh. Areas in this section were deeper up to 9 ft in areas. Sample consisted of very fine silts with some organic material. Sample was black and gray in color. Sample was collected from 2-12 inches in depth from 3 ft. of water.

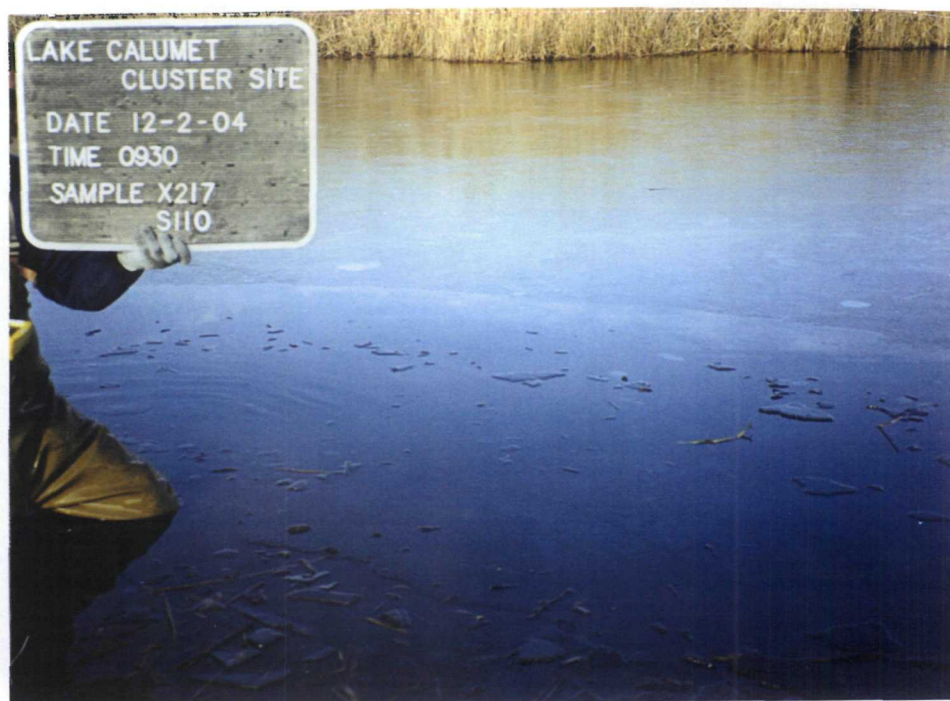
DATE: December 2, 2004
TIME: 0930
PHOTO BY: L. Range
PHOTO NUMBER: 2
ROLL NUMBER: 5
DIRECTION: Northwest
COMMENTS: Photo taken of sample X217 and S110. S110 was collected from a depth of 10 inches from a clear water. Water depth was 1 ft. X217 was collected from the SE portion of the pond. Sample consisted of very fine silty black clay. Depth of sample was 2-12 inches.

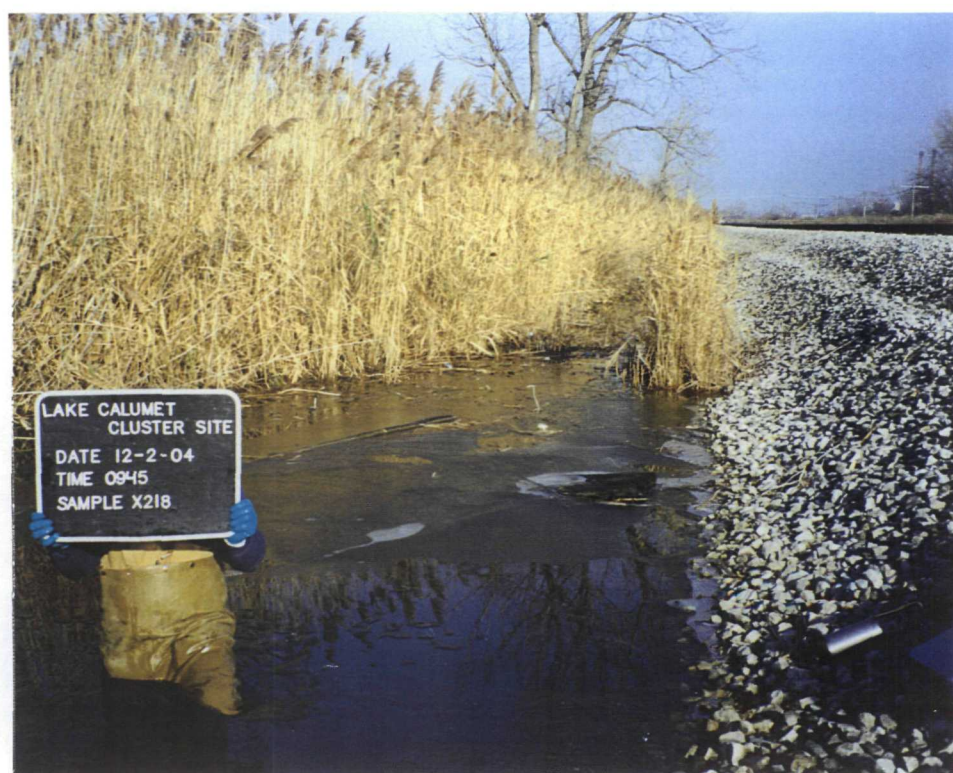
DATE: December 2, 2004
TIME: 0945
PHOTO BY: L. Range
PHOTO NUMBER: 3
ROLL NUMBER: 5
DIRECTION: East
COMMENTS: Photo taken of sample X218. X218 was collected from the northeast corner of the pond located on the Cluster site. Sample was collected from a depth of 2-12 inches. Sample consisted of soft black silts with some black clay and organic material. Depth of water was 2 ft.

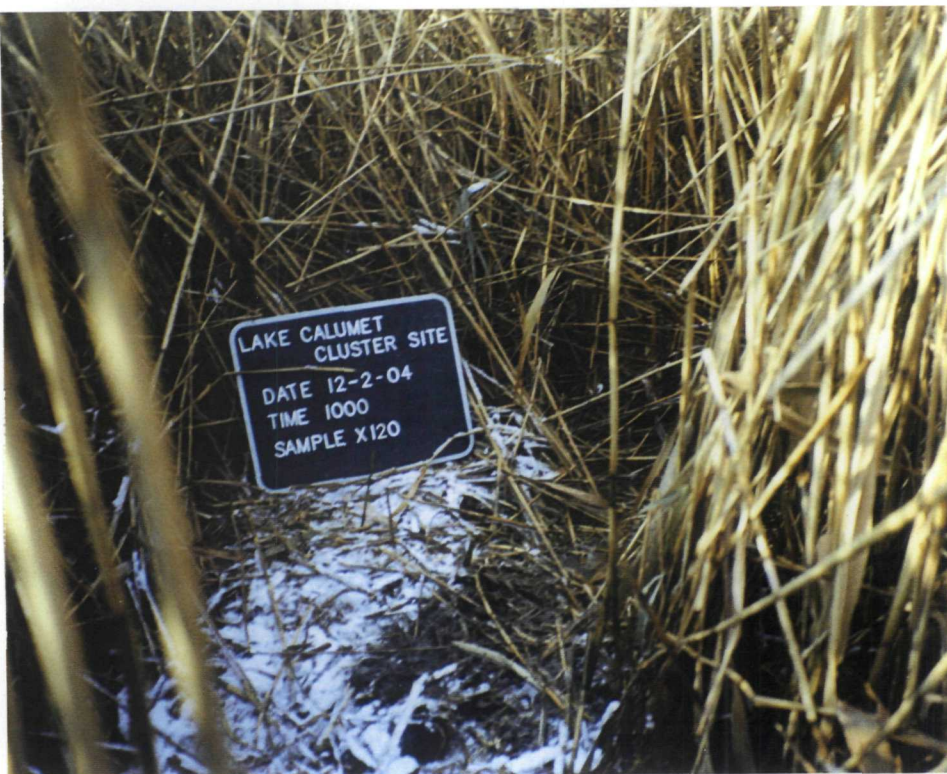
COMMENTS: Photo taken of sample X120. X120 was collected from the ditch located on the south boundary of the Cluster site, paralleling 122nd St. Sample consisted of a brown sand with very little silt. Sample was collected from a depth of 2-9 inches. Strange smell detected.

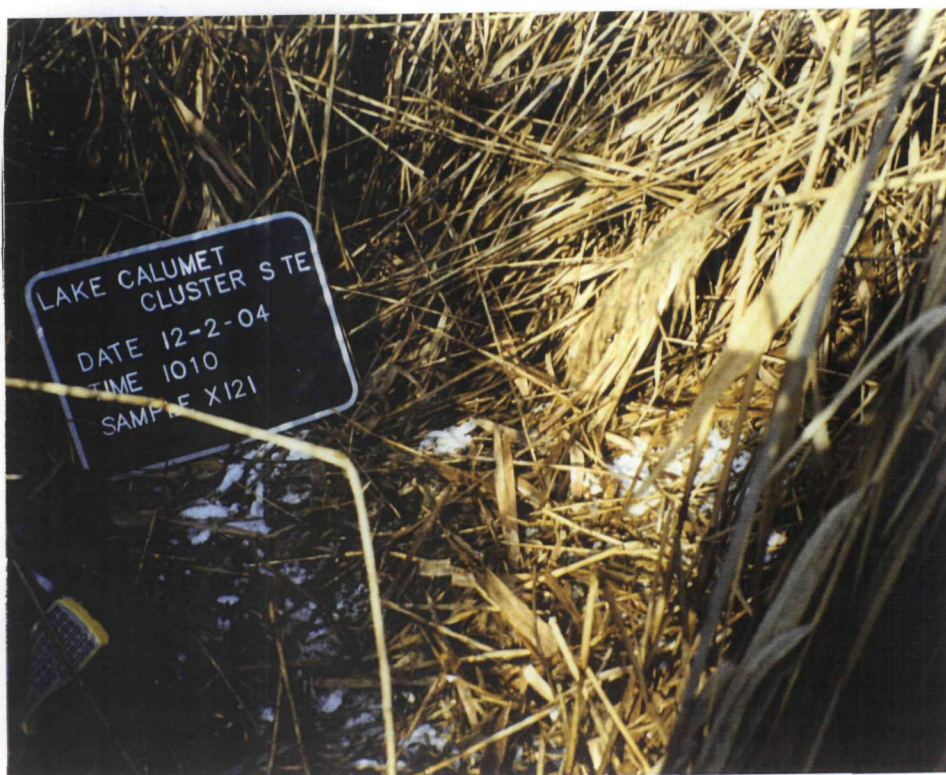
COMMENTS: Photo taken of sample X121. This sample was also collected from the ditch area. Sample consisted of a dry loam that was brown in color. Sample was collected from a depth of 2-12 inches. Sample also contained phragmites roots and debris.

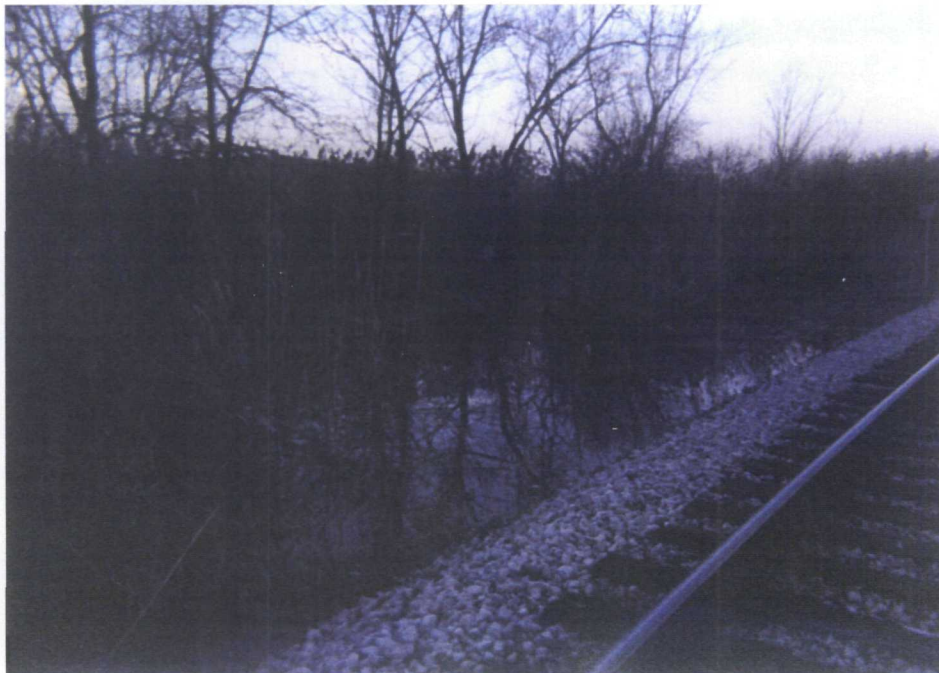
COMMENTS: Photo taken from the southeastern corner of the small wetland area located south of the US Drum portion and north of the unnamed parcel. Photos taken from railroad tracks towards the north document conditions of the wetland area.

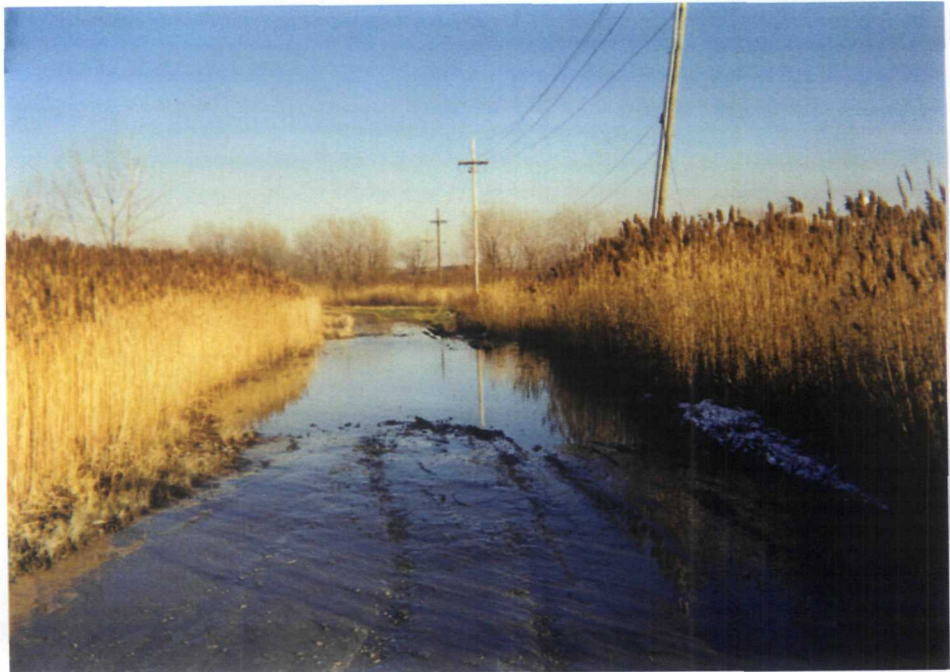
COMMENTS: Photo taken of from the northern boundry of the US Drum property. Photo taken towards the southeast. Photo documents standing water on the US Drum property.

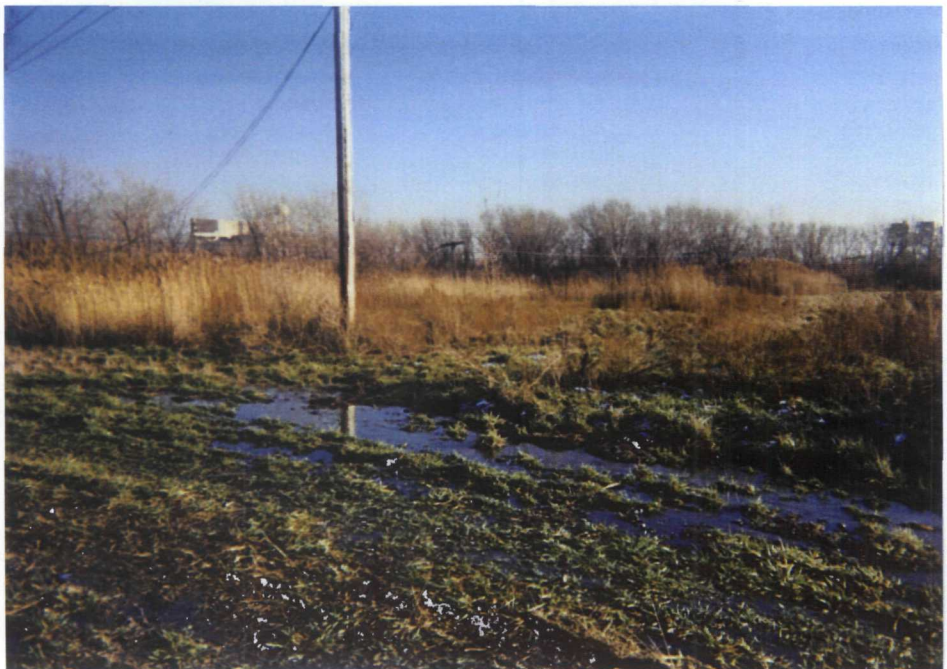
COMMENTS: Photo taken of from the north central portion of the US Drum Property. Phot taken towards the northeast. Documents standing water on the eastern portions of the US Drum site before entering the Railroad ditch.

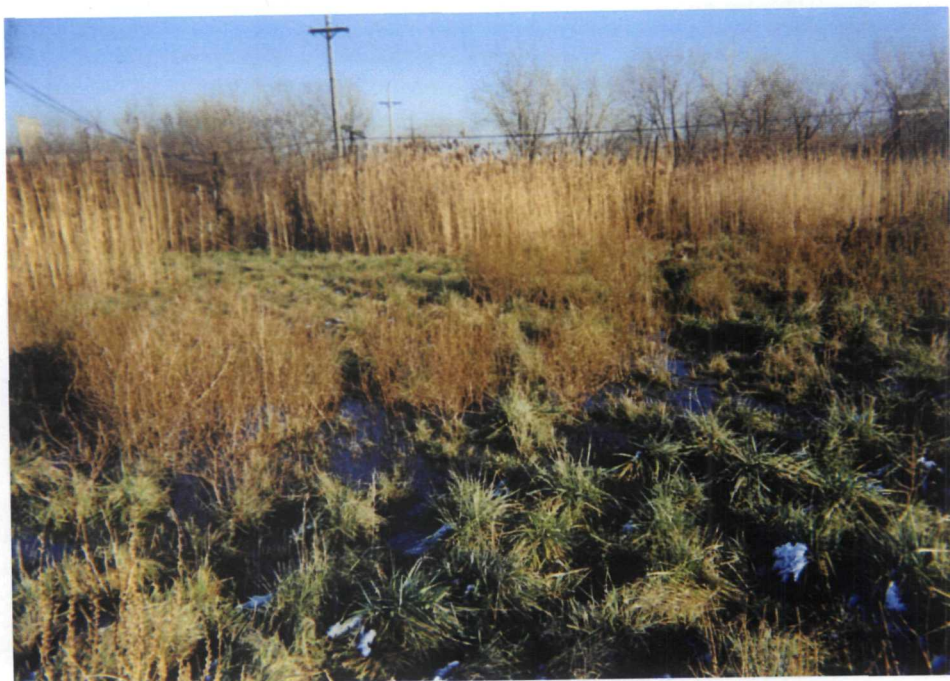
COMMENTS: Photo taken from the northeast portion of the US Drum property. Photo taken towards the east. Documents standing water as it flows through tall grass just before entering the railroad ditch.

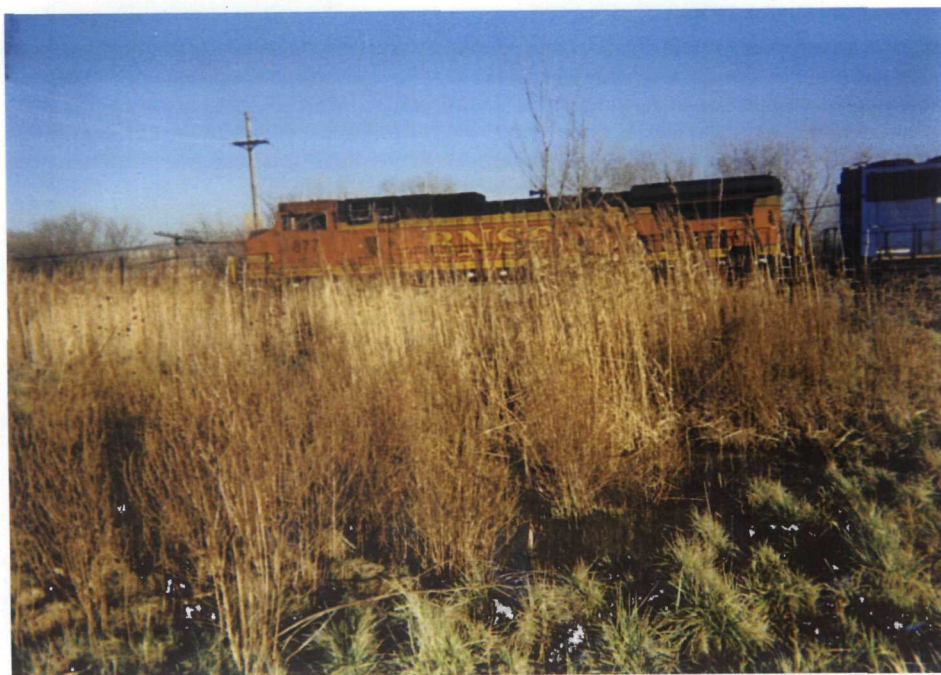
COMMENTS: Photo taken from the east central portion of the US Drum property. Photo taken towards the northeast. Documents standing water on the US Drum site leaving the site before flowing into the western railroad ditch.

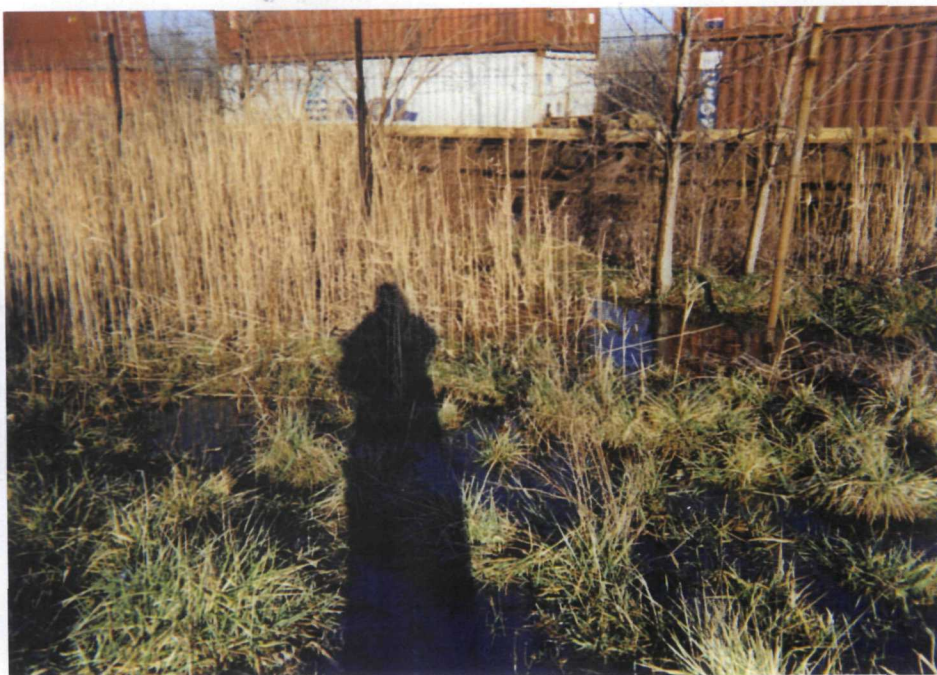
COMMENTS: Photo taken from the same location as photo 5, but more towards the north. Documents standing water on the US Drum property flowing into the western railroad ditch.

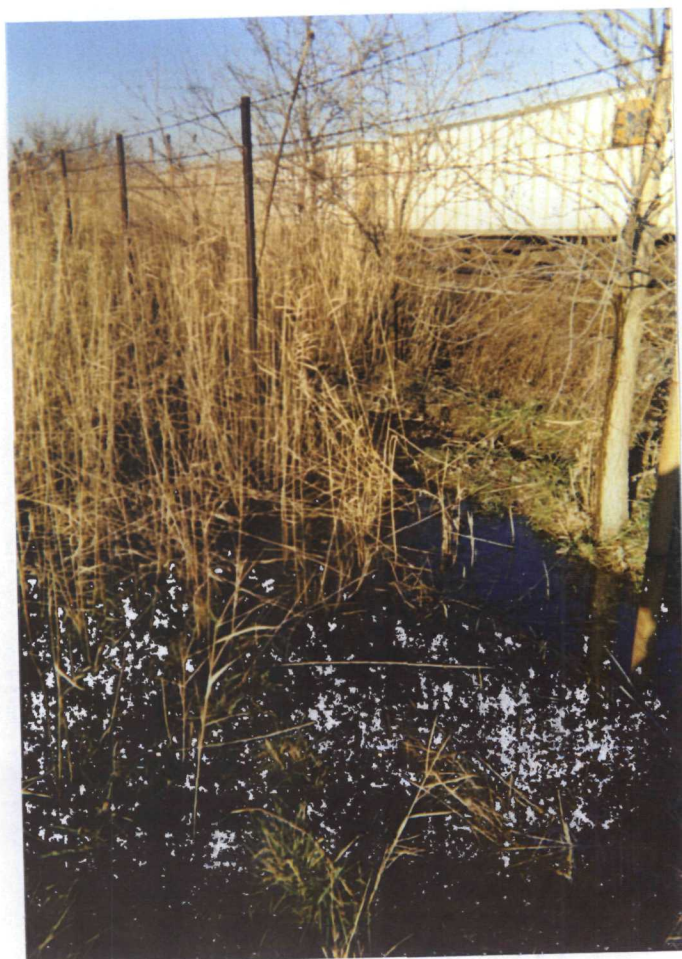
COMMENTS: Photo taken from the western railroad ditch adjacent to US Drum site. Photo taken towards the west, documents the surface water flowing from the US Drum site and entering the western railroad ditch.

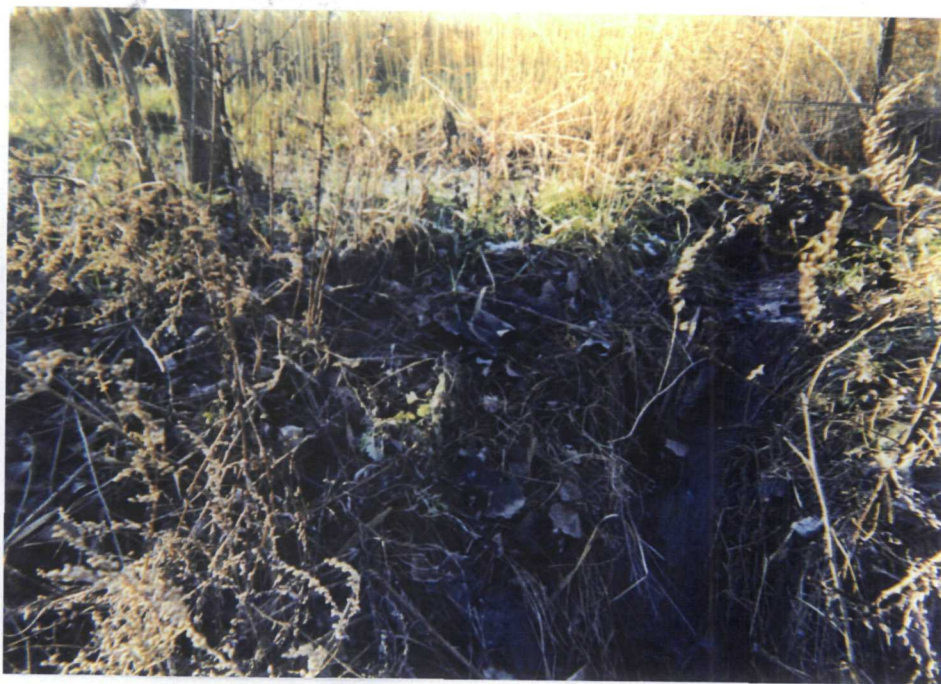
COMMENTS: Photo taken from the railroad ditch and documents surface waters flowing from US Drum property into the western railroad ditch. Same location as photo 7.

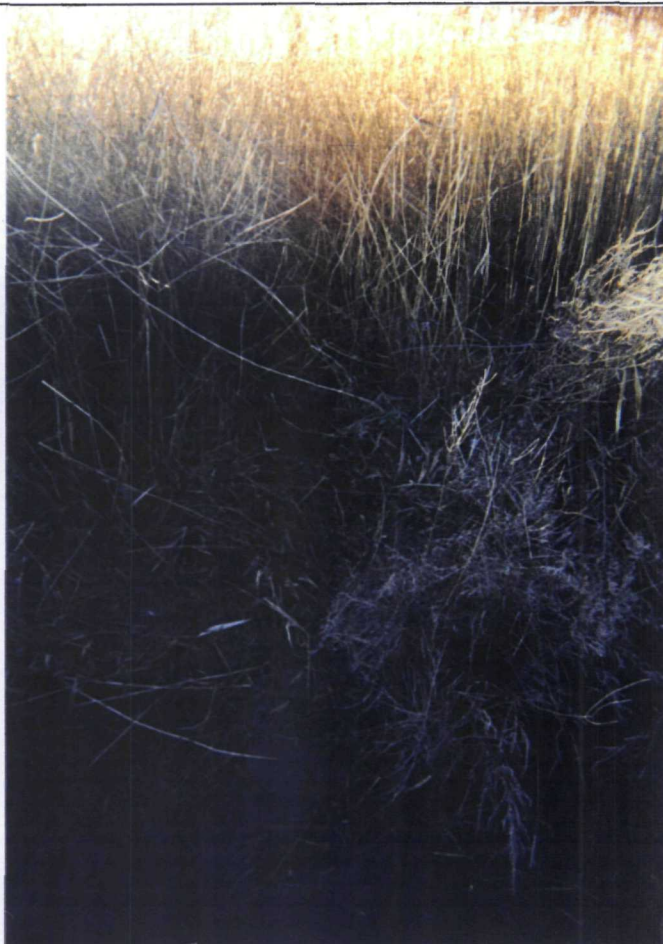
COMMENTS: Photo taken from the western railroad ditch adjacent to the US Drum site. Photo taken towards the north documents surface water within ditch as it flows north towards the culvert running under the railroad tracks and flowing into Indian Ridge Marsh.

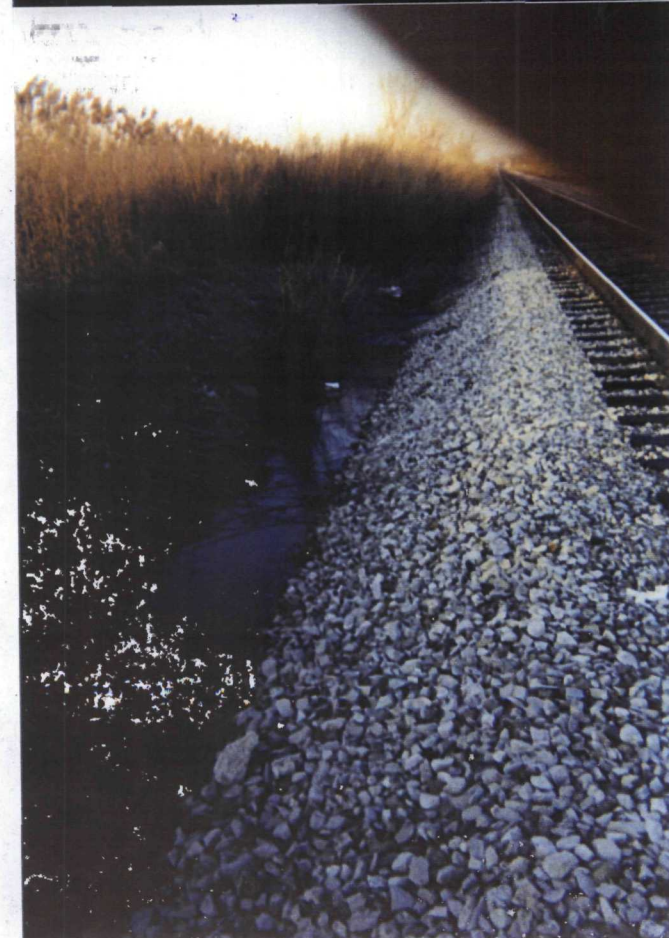
COMMENTS: Photo taken from the western railroad ditch approximately 5 yards south of the culvert. Photos taken towards the north documents surface waters from the western railroad ditch entering culvert which flows into IRM.

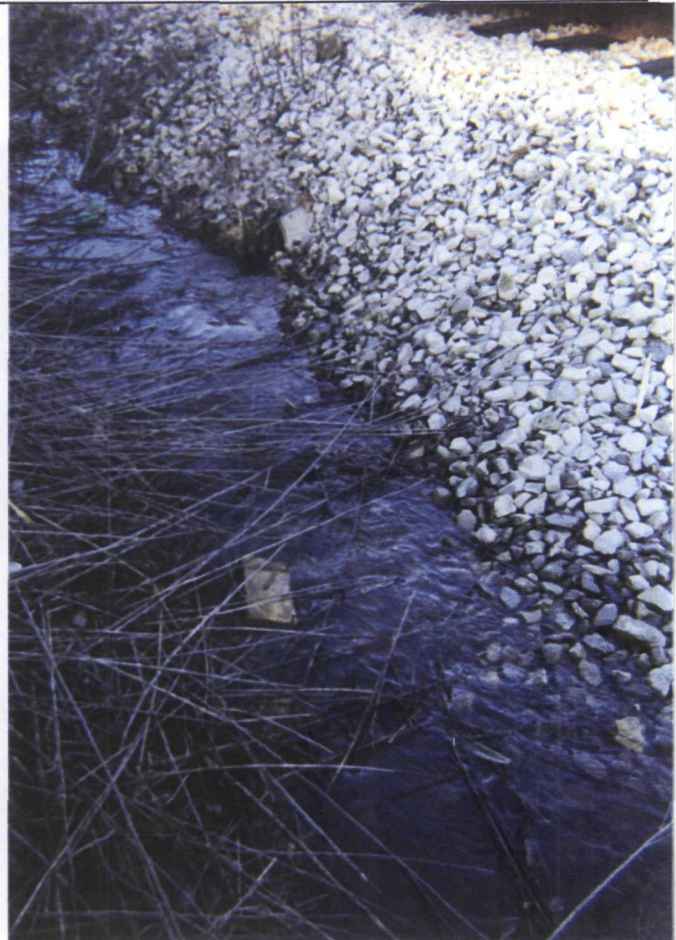
COMMENTS: Photo taken from the western railroad ditch approximately 5 yards south of the culvert. Photos taken towards the northeast documents surface waters from the western railroad ditch entering culvert which flows into IRM.

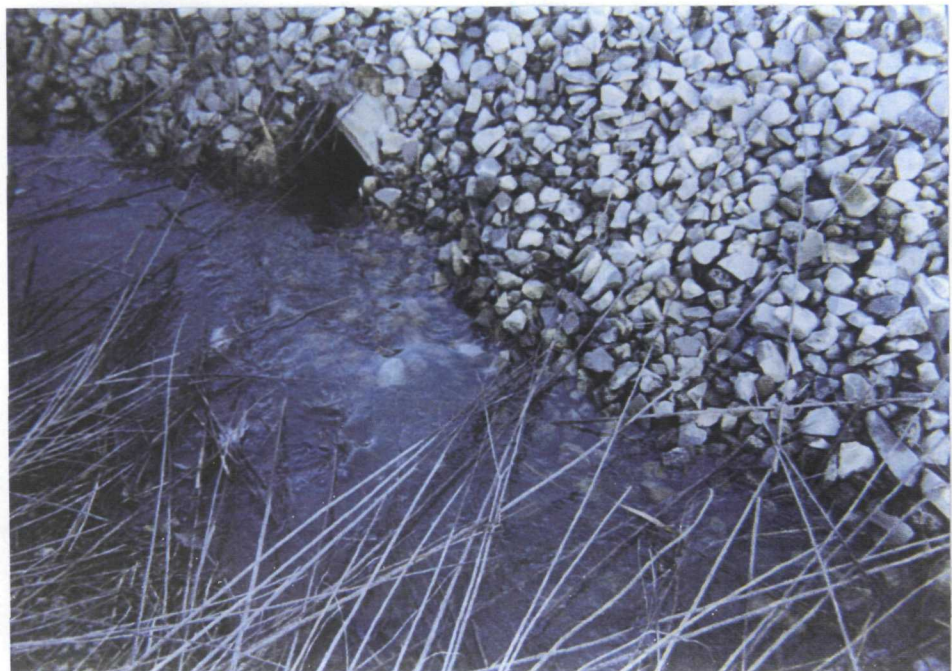
COMMENTS: Photo taken from the Railroad tracks at the point where the culvert empties into IRM. Photos taken towards the east and document the flow of surface waters from the western railroad ditch into IRM.

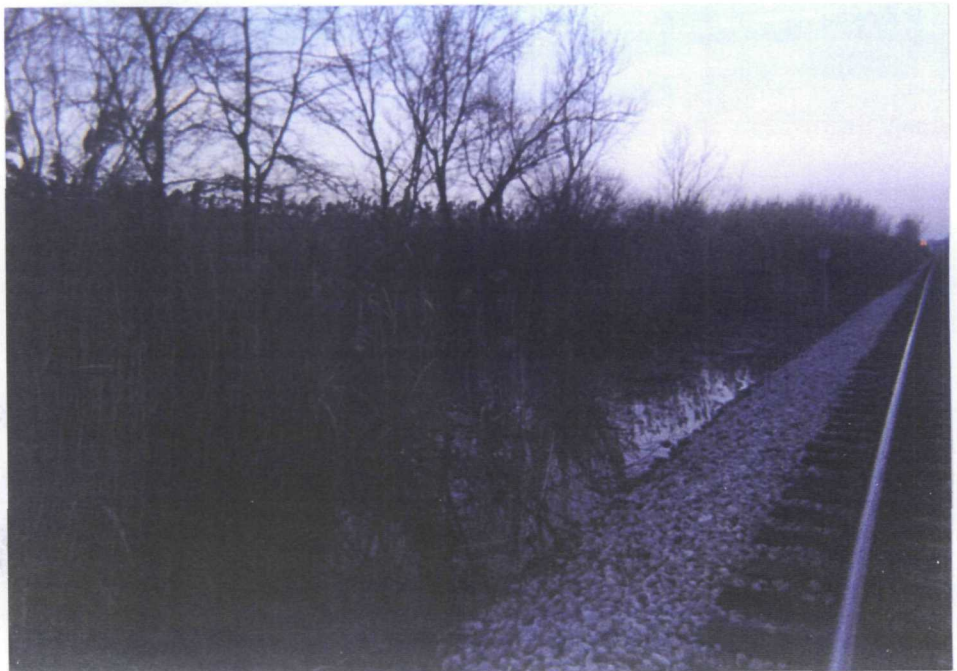
COMMENTS: Photo taken from the southeastern corner of the small wetland area located south of the US Drum portion and north of the unnamed parcel. Photos taken from railroad tracks towards the north document conditions of the wetland area.
